## Reliability Analysis, High Voltage Plastic Capacitors

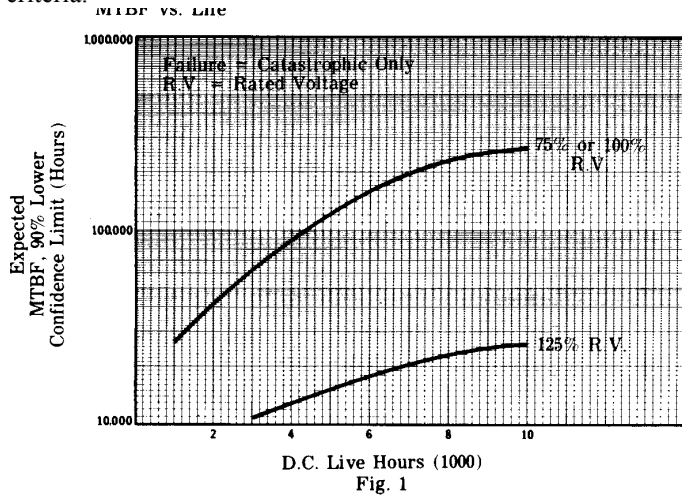
1. Catastrophic Failures (shorts):  
No catastrophic failures at either 75% or 100% of rated voltage occurred during the 10,000 hours of test (See Appendix A). This data indicates a MTBF (90% confidence limit) of greater than 260,000 hours at applications of rated voltage or less. Thirteen (13) catastrophic failures occurred at 125% of rated voltage (See Appendix A). This data indicates a MTBF of greater than 26,648 hours at applications of greater than rated voltage (See Fig. 1).

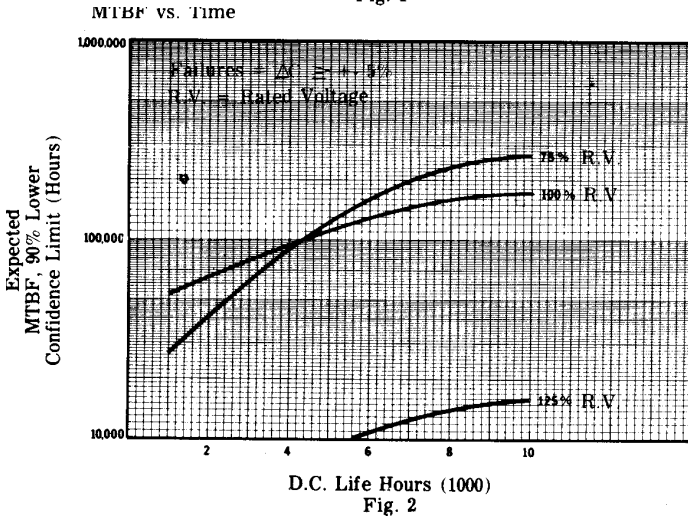
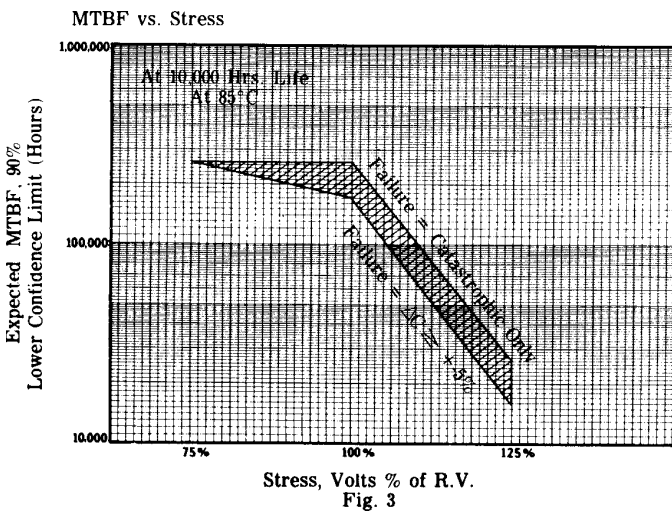
The changes at 75% and 100% of rated voltage (less than -1%) appear normal; however, -34% capacitance change at 125% rated voltage indicated further analysis of this potential failure mode was required (See Appendix B). Following this analysis additional failure criteria of +5% and +10% capacitance change were established, and new failure criteria was established (See Appendix A). The new failure criteria

does not significantly effect MTBF at 100% R.V. or less; however, at stresses greater than 100% the MTBF begins to be degraded. A capacitance change criteria of +5% is consistent with most military and industrial requirements; hence, the plots in Figures 2 and 3 have not included the +10% of criteria.

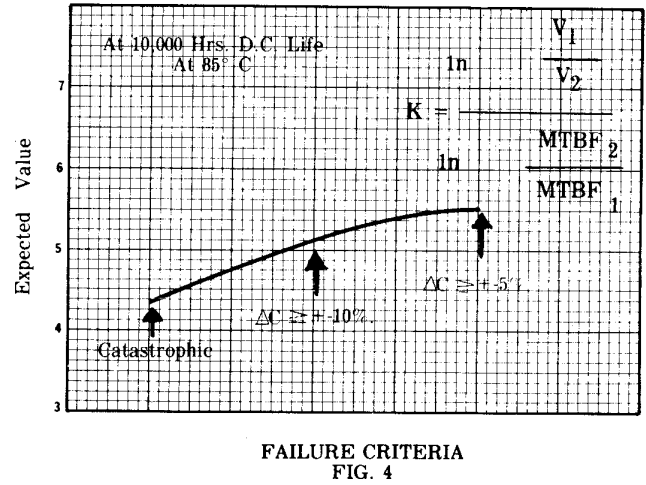
"K" vs. Failure Criteria

which states that one would expect the MTBF ratios and voltage stress ratios to behave as the 5<sup>th</sup> power. The data was examined for values of "K" under different failure criteria (See Appendix A). It was expected that "K" should fall in the range 5 to 7. The data behaved as expected (See Fig. 4).
